# Inspection Report

**Twinspectors**

**77 Effingham Street Tarragindi QLD 4121**

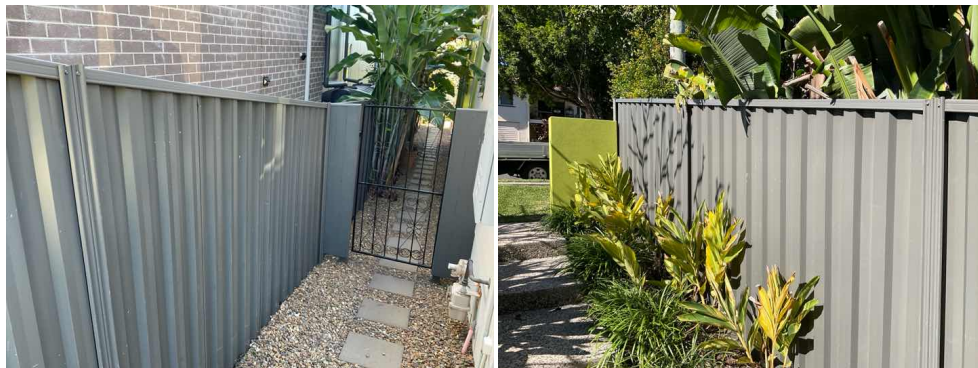
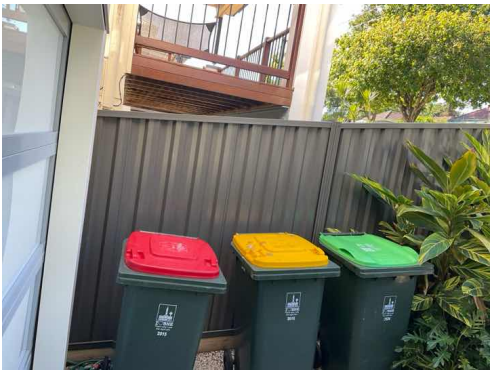
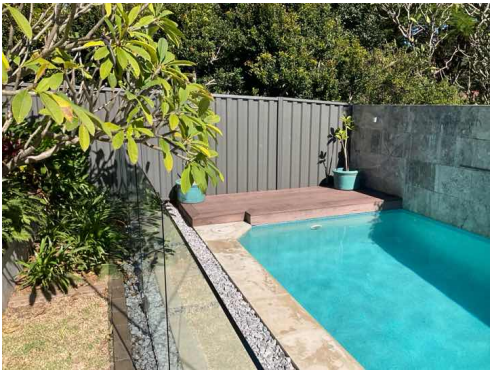
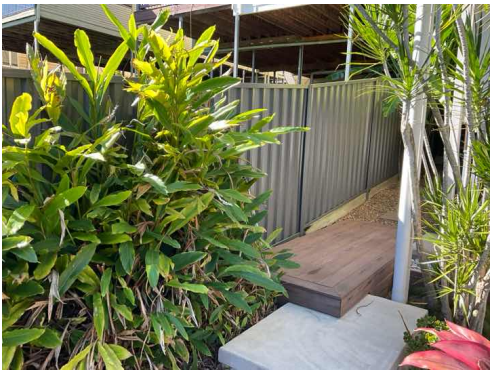
Impact damage noted to some fence panels.

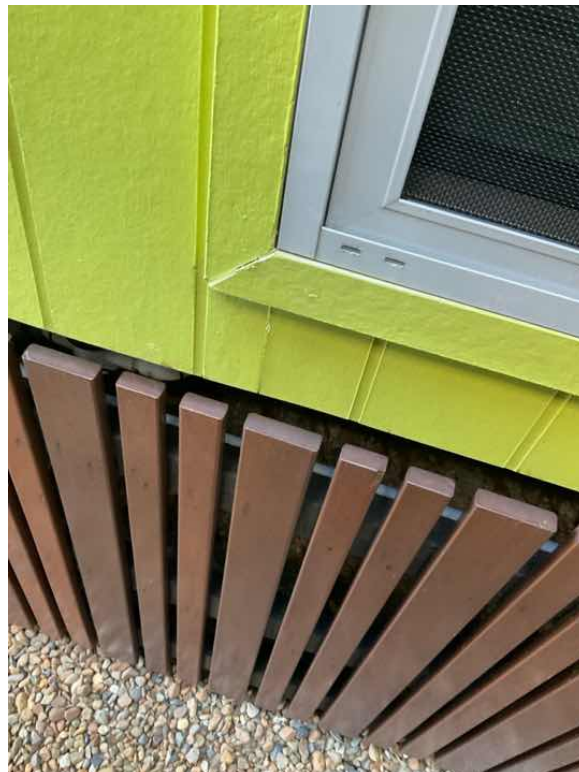
#2. fibro cement window trim coming loose near subfloor entry contact licensed carpenter for repair repairs

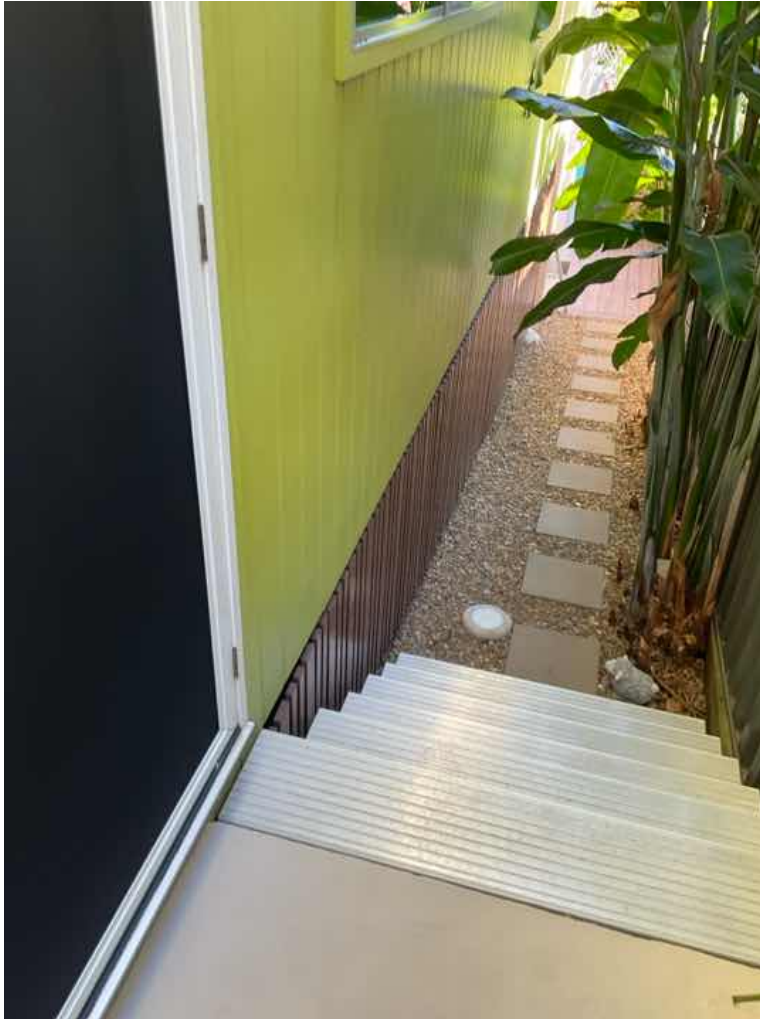
#3. There are no rails on the stairs. This presents a fall risk. Recommended to install

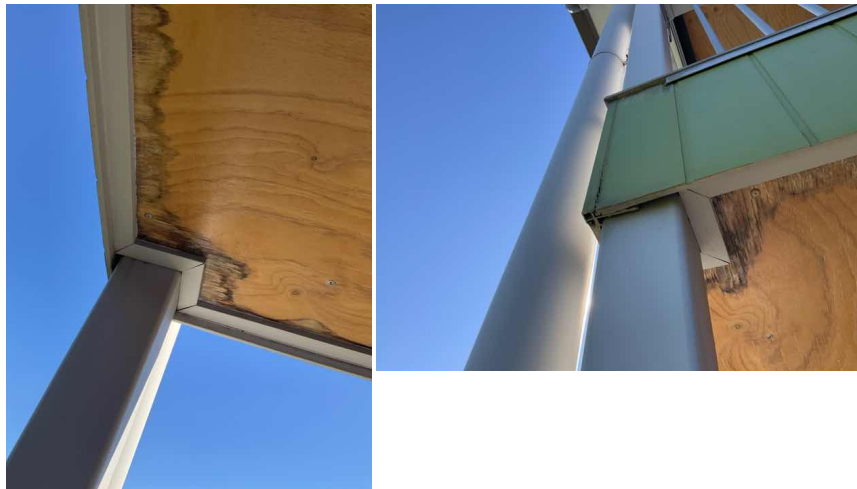
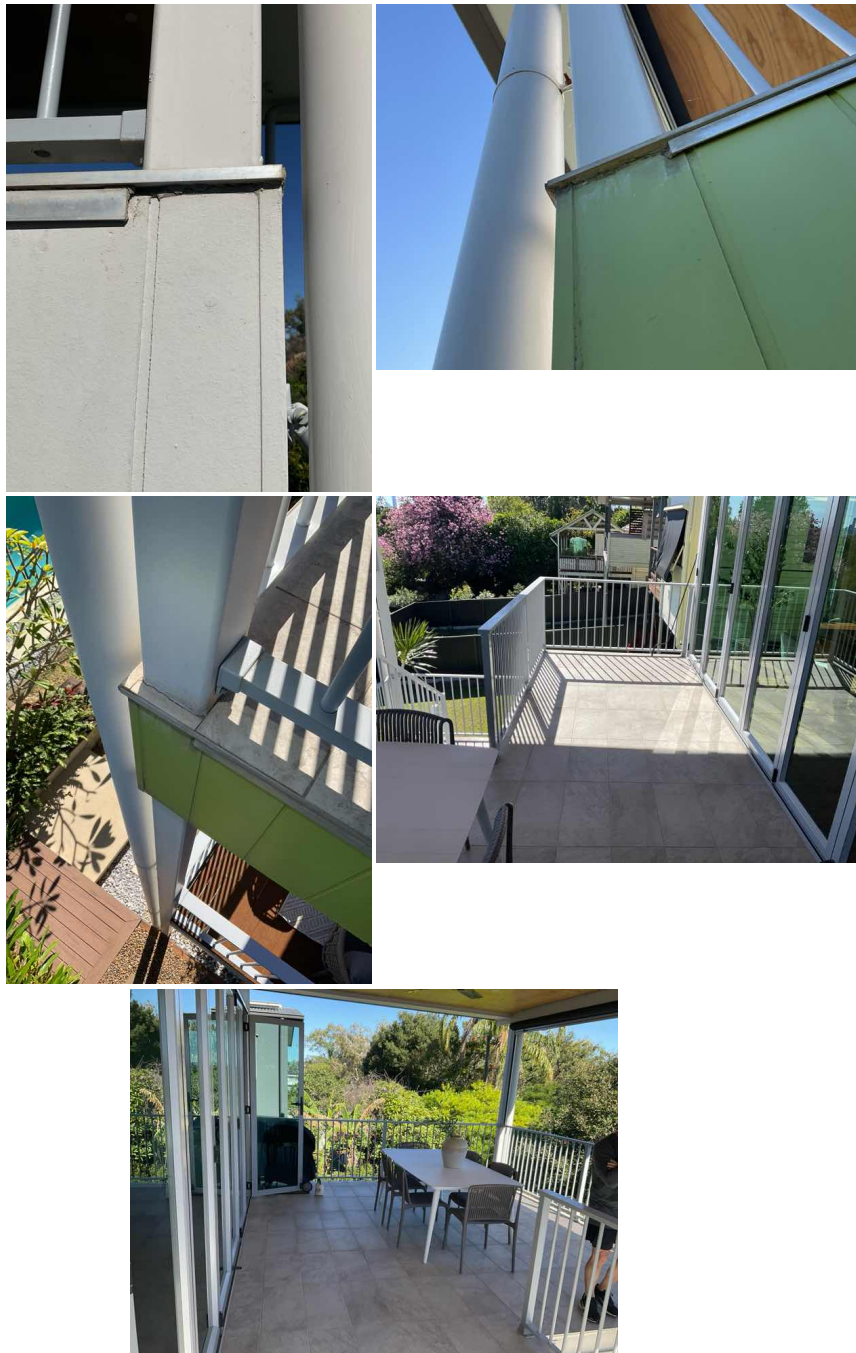
#4. Additional sealant or waterproofing may be necessary on top floor balcony edge coping contact licensed tiler or waterproofing contractor for repair repairs

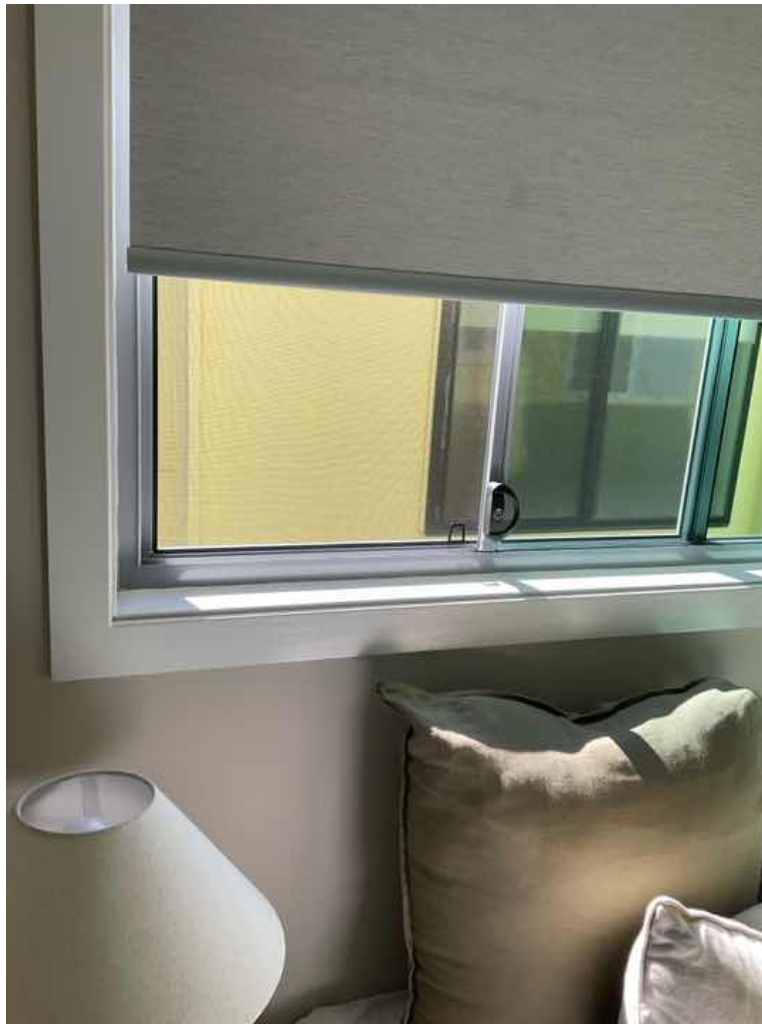
#5. The opening limiter/restrictor is missing. Ensure one is installed to every window with accord to state requirements.

Window openings should not exceed 125mm. In some circumstances, we strongly advise you to rectify to comply with safety concerns to young children.

This has been identified in most upstairs bedrooms.

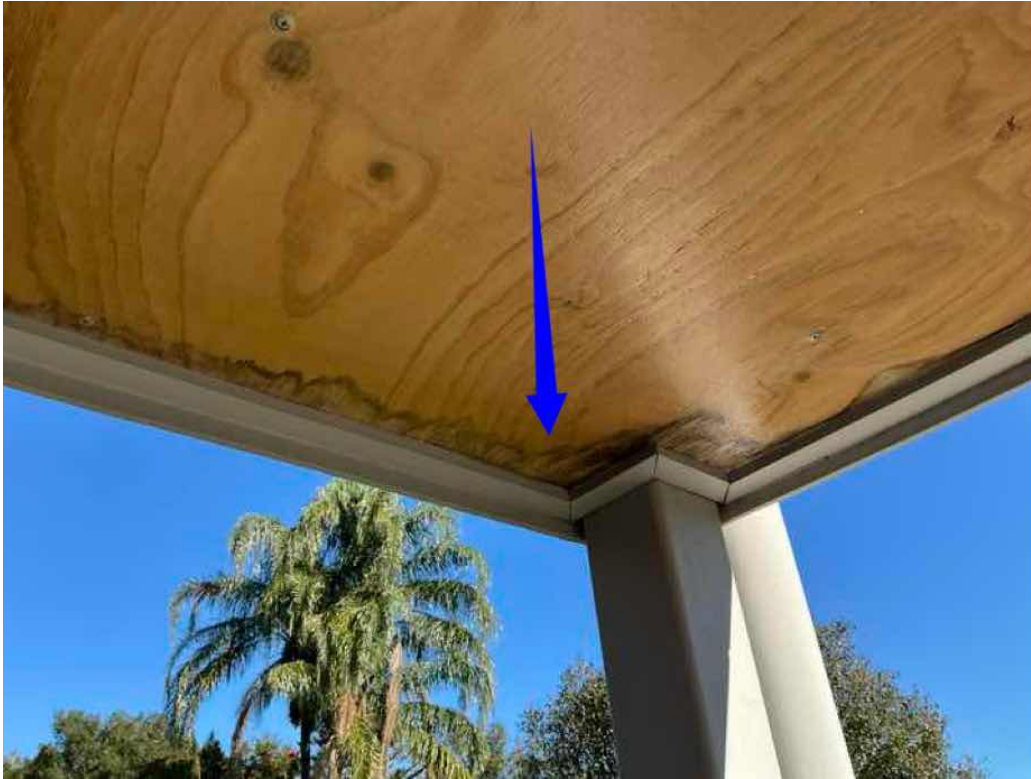
#1. During the inspection it was noted that water stains were visible in the following areas.

**Patio ceiling, refer to building report for further information.**
