# Inspection Report

**Twinspectors**

**77 Effingham Street Tarragindi QLD 4121**

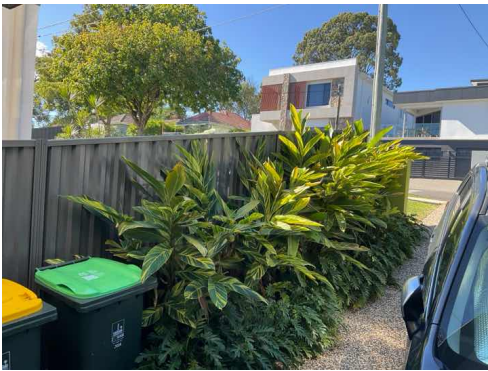
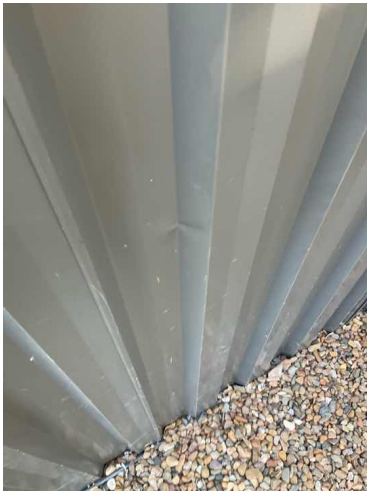
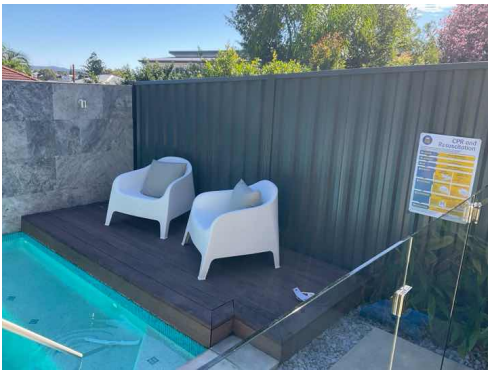
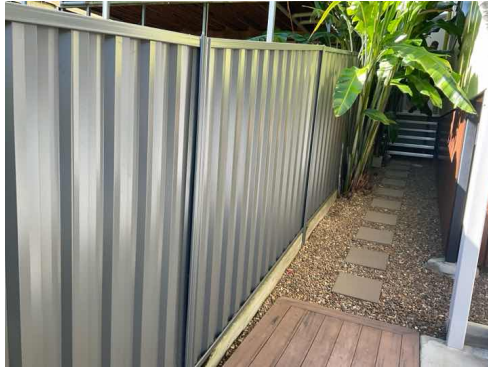
Impact damage noted to some fence panels.

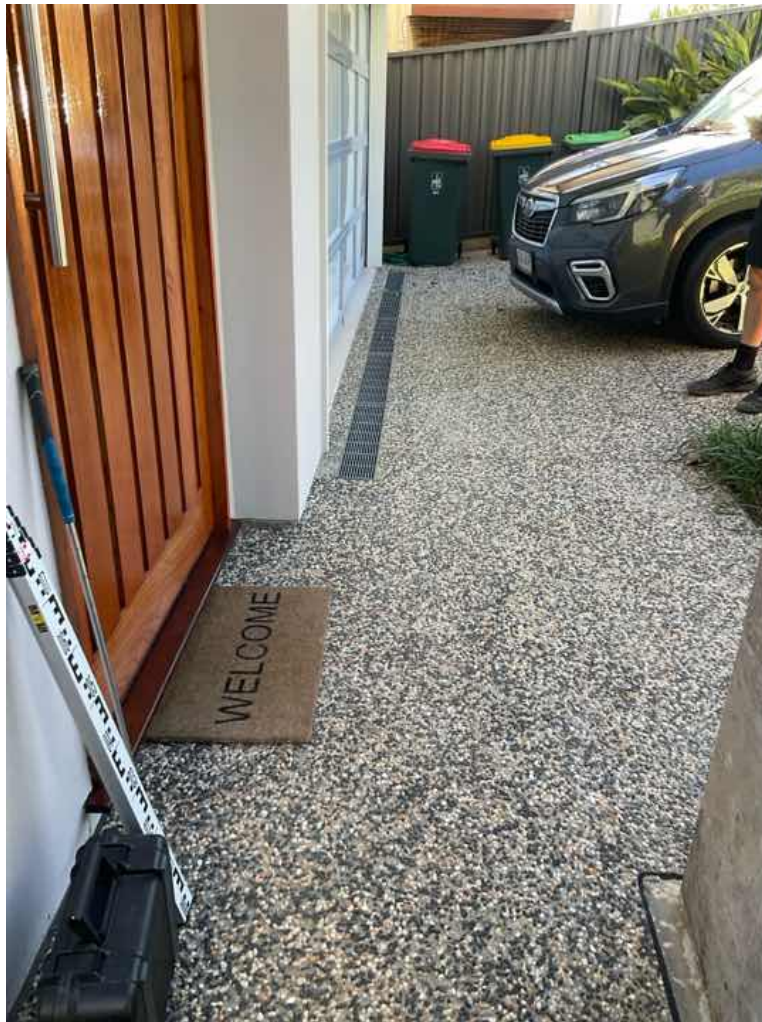
#1. The ground levels along the perimeter walls at the front of the home did not appear to fall away from the property walls sufficiently due to the natural landscape and contour. This will need to be assessed during a period of rainfall and if surface water appears to be entering the sub floor if applicable or ponding against the perimeter walls, engage a plumber or landscaper to assess and rectify as required. All drains should be regularly checked by a plumber and kept clean of debris to allow surface water to be carried away from the dwelling.

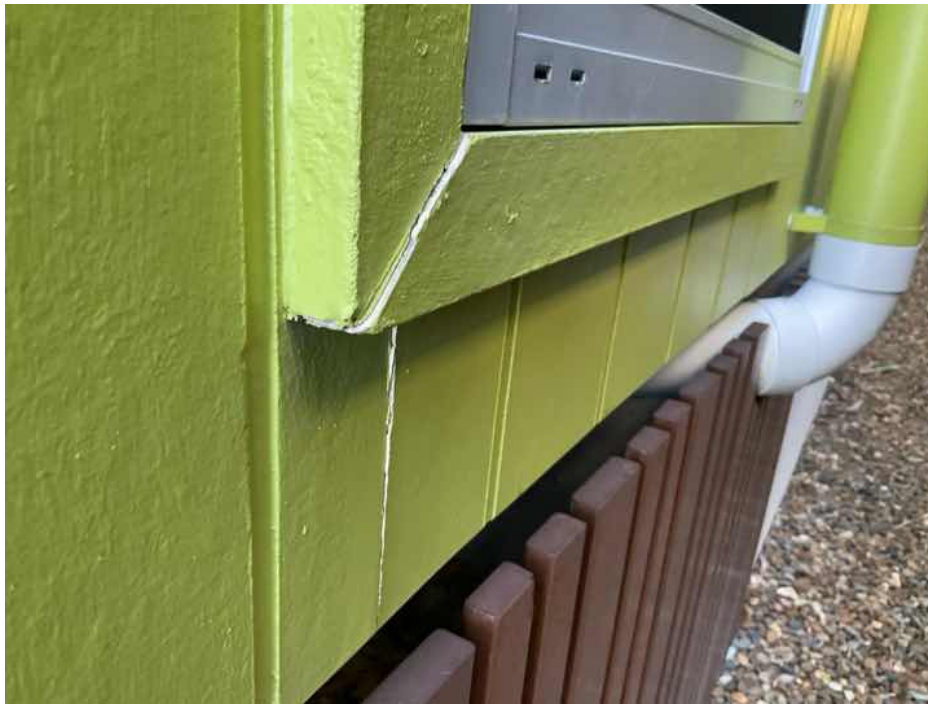
| Section | Location | Name | Comment |
|---|---|---|---|
| EXTERIOR | Walls | Condition | #2. fibro cement window trim coming loose near subfloor entry contact licensed carpenter for repair repairs |

#2. fibro cement window trim coming loose near subfloor entry contact licensed carpenter for repair repairs

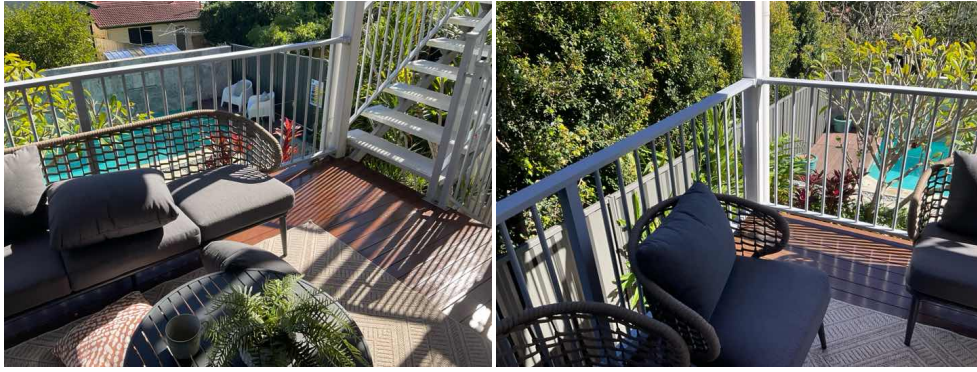
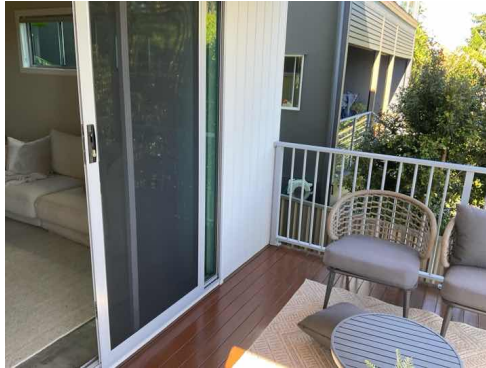
| Section | Location | Name | Comment |
|---|---|---|---|
| STAIRS-<br>PERGOLA-<br>BALCONIES-<br>DECKS | Stairs & Steps | Balustrade and Rails | #3. There are no rails on the stairs. This presents a fall risk. Recommended to install |

#3. There are no rails on the stairs. This presents a fall risk. Recommended to install

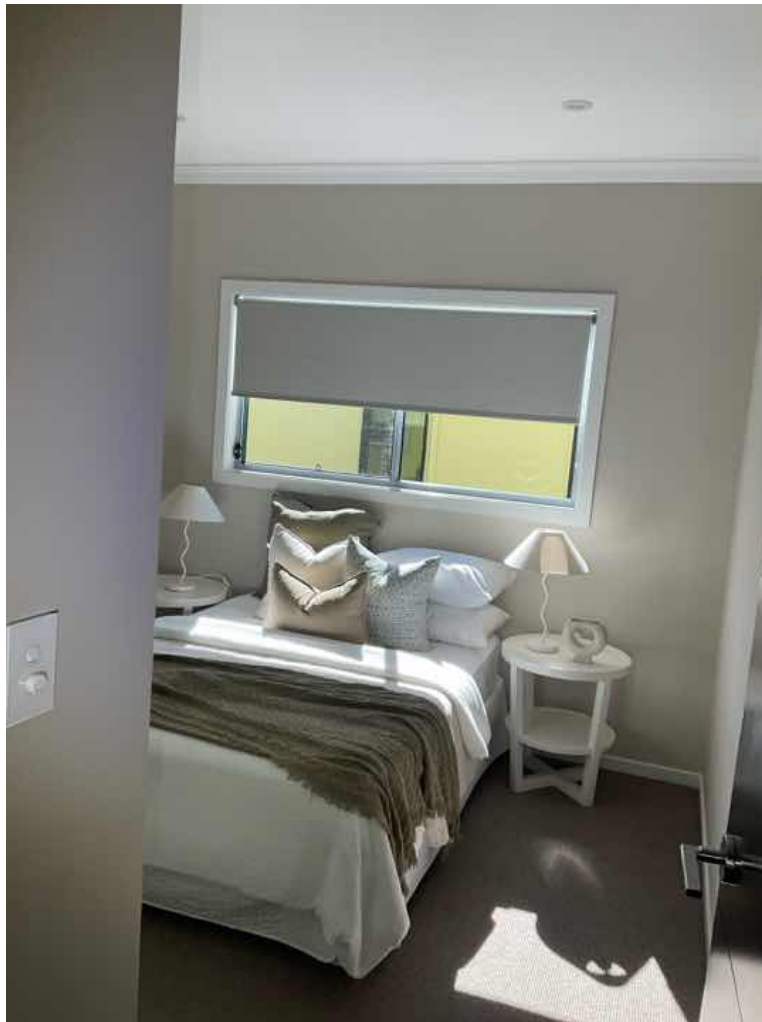
| Section | Location | Name | Comment |
|---|---|---|---|
| INTERIORS | Bedroom 2 | Windows | #5. The opening limiter/restrictor is missing. Ensure one is installed to every window with accord to state requirements. Window openings should not exceed 125mm. In some circumstances, we strongly advise you to rectify to comply with safety concerns to young children. This has been identified in most upstairs bedrooms. |

#5. The opening limiter/restrictor is missing. Ensure one is installed to every window with accord to state requirements.

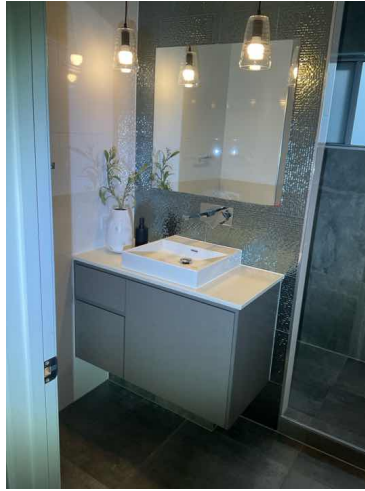
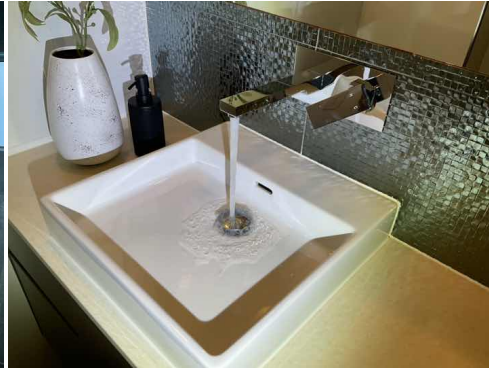
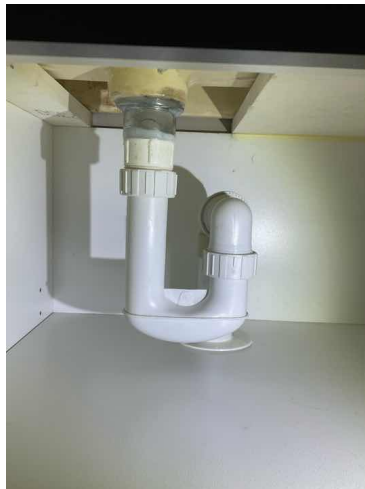
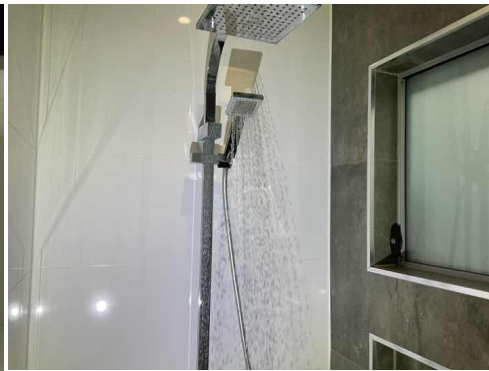
Of the visible areas, the general condition of this bathroom is serviceable or in reasonable condition for age of dwelling.

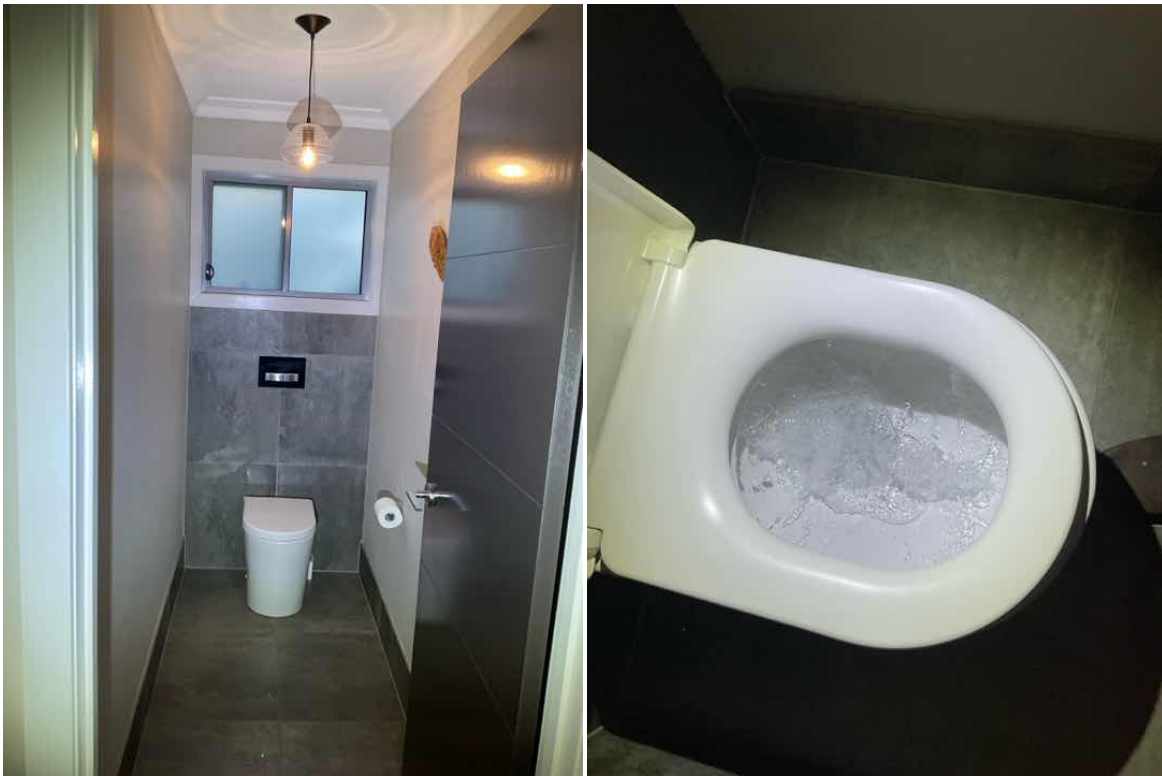
## **Toilet/Outhouse**

Of the visible areas, the general condition of this bathroom is serviceable or in reasonable condition for age of dwelling.

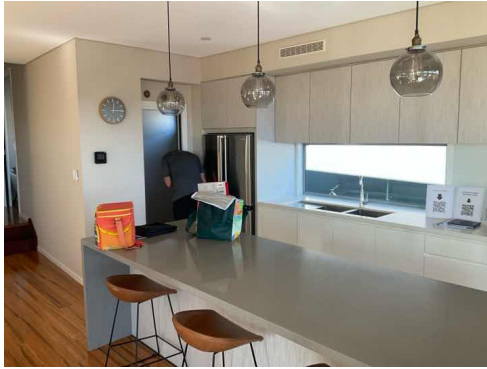
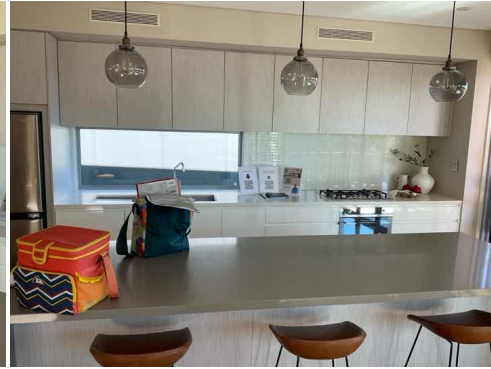
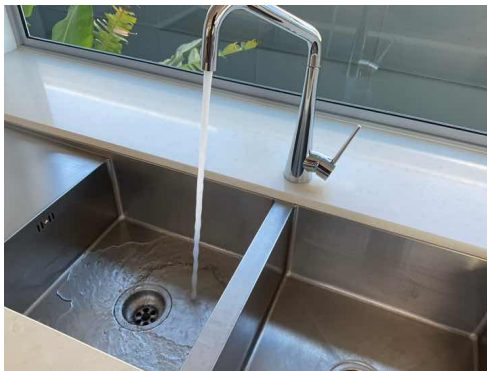
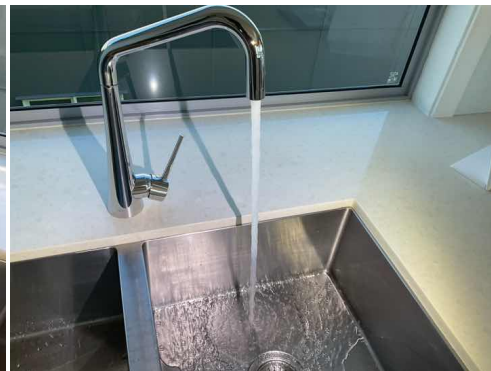
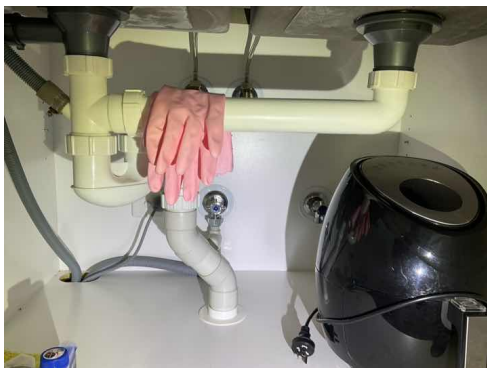
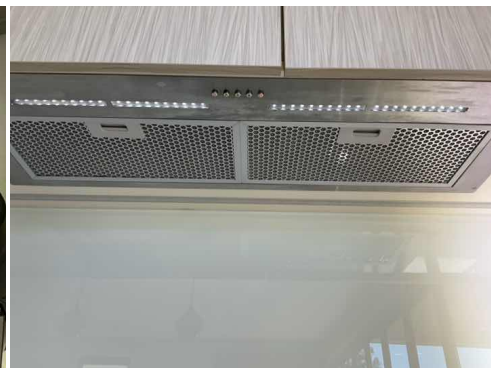
Of the visible areas, the general condition of the kitchen and pantry is serviceable or in reasonable condition for age of dwelling.

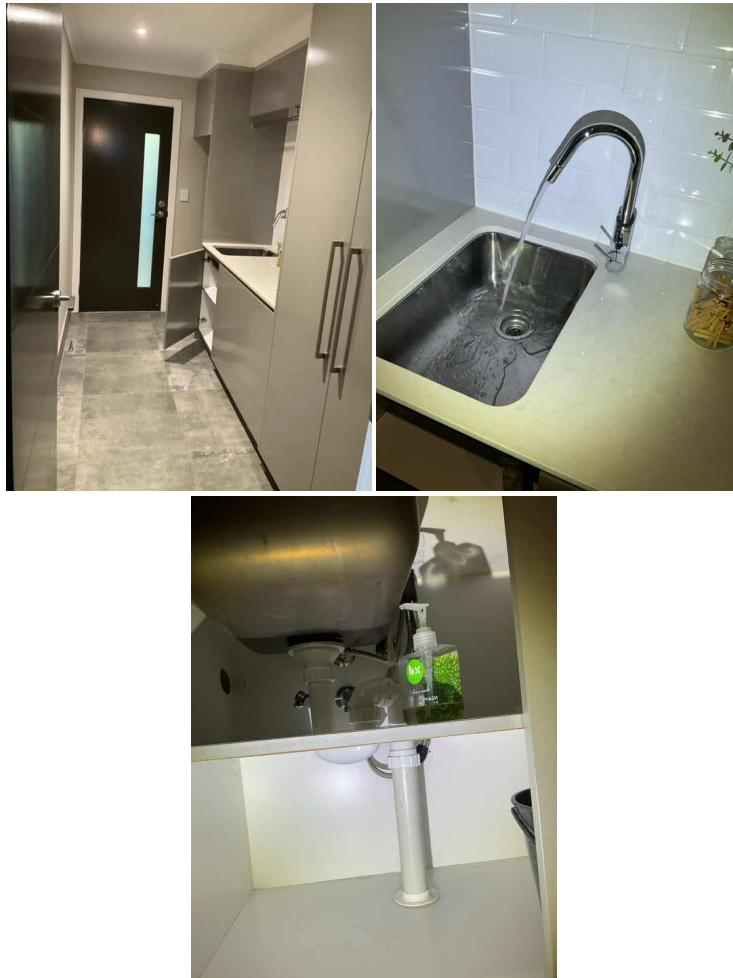
## Laundry

Of the visible areas, the general condition of the laundry is serviceable or in reasonable condition for age of dwelling.

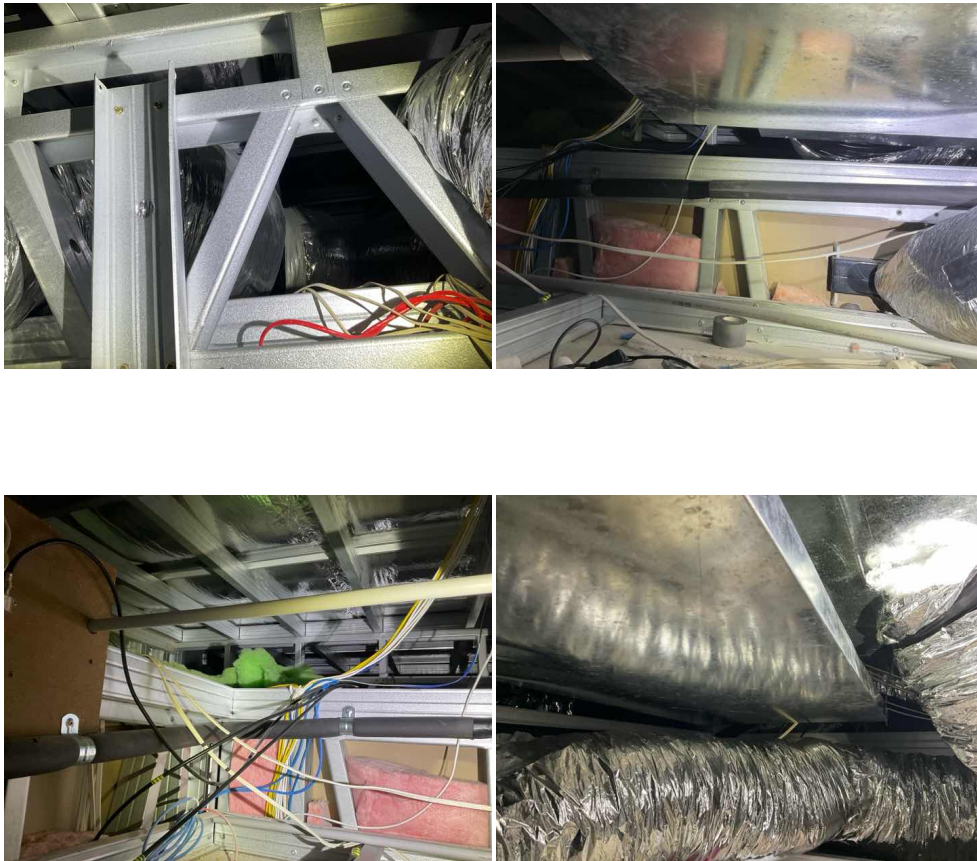
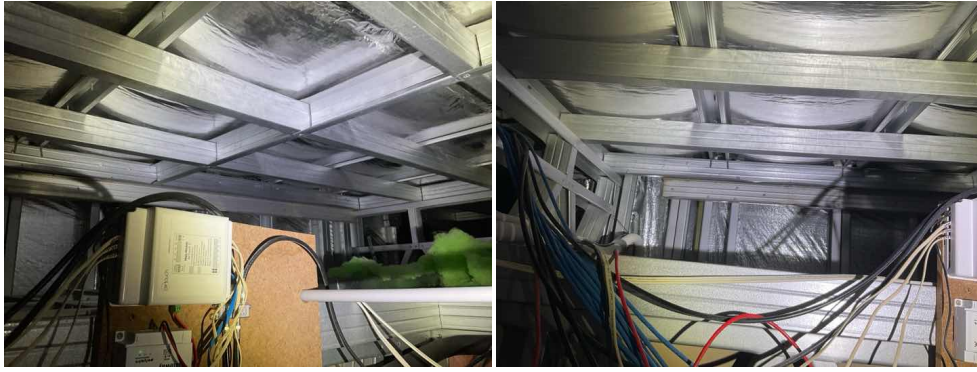
There is heating and/or cooling ducting present in the roof space. This is preventing a full inspection from being undertaken. It is strongly recommended that full access be gained as it could be harbouring timber pest activity, damage or defects.

There is low clearance in areas throughout the roof void which is preventing a full/thorough visual inspection taking place. It is strongly recommended that full access be granted to enable a thorough inspection to take place as it could be harbouring timber pest activity, damage or defects.

Viewed from out side due to restricted entry. No comment can be made regarding condition

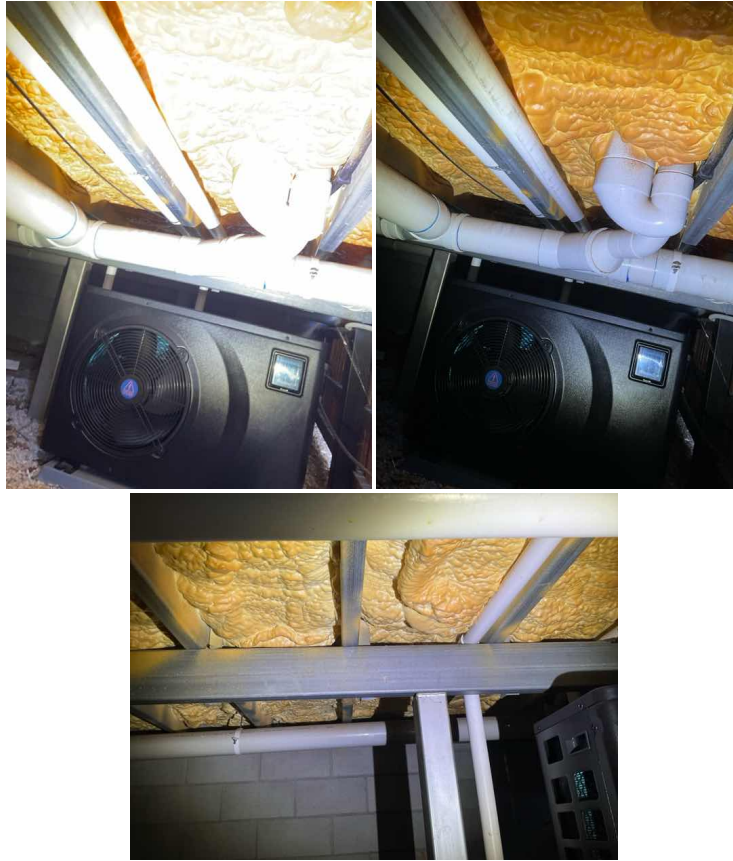
#### Restricted Areas

Underside of timbers could not be inspected as they were concealed by insulation. There may be issues there. We recommend re-inspection with all timber members visible.

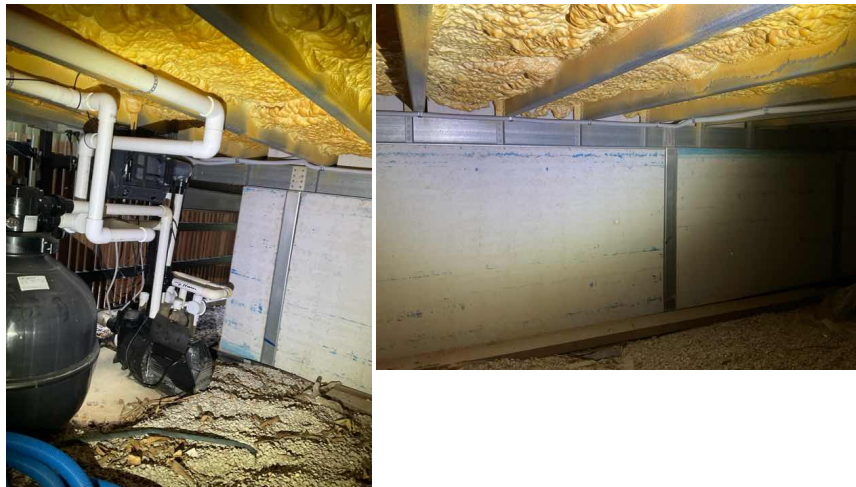
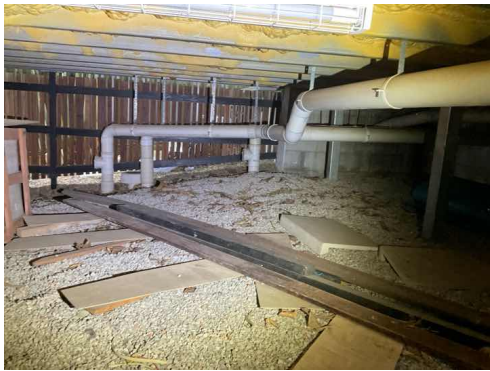
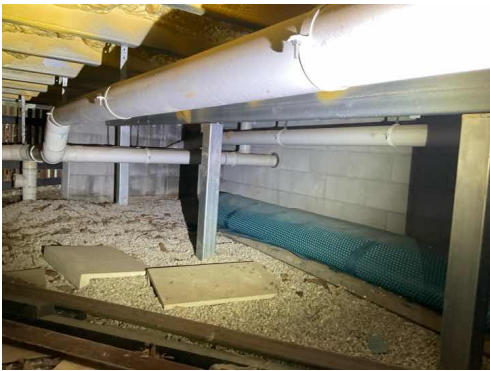
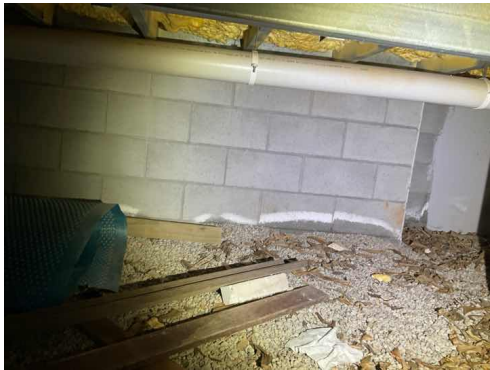
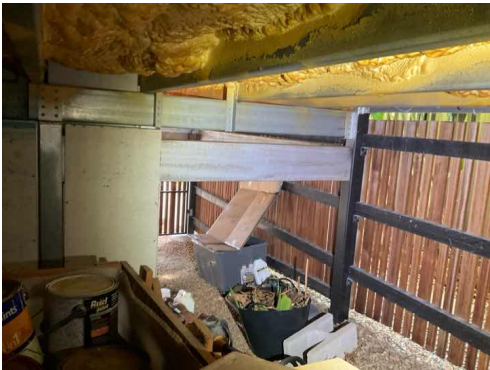
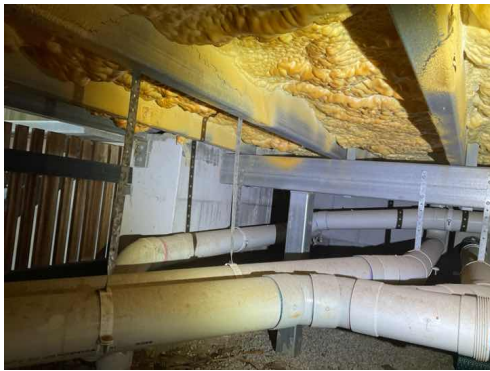
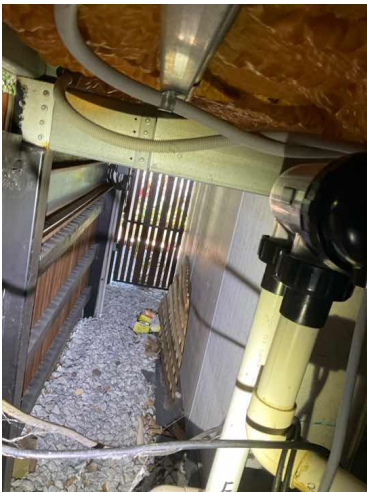
### Sub-Floor Observation.

Of areas accessible and visible, the subfloor and components appeared to be in a serviceable condition.

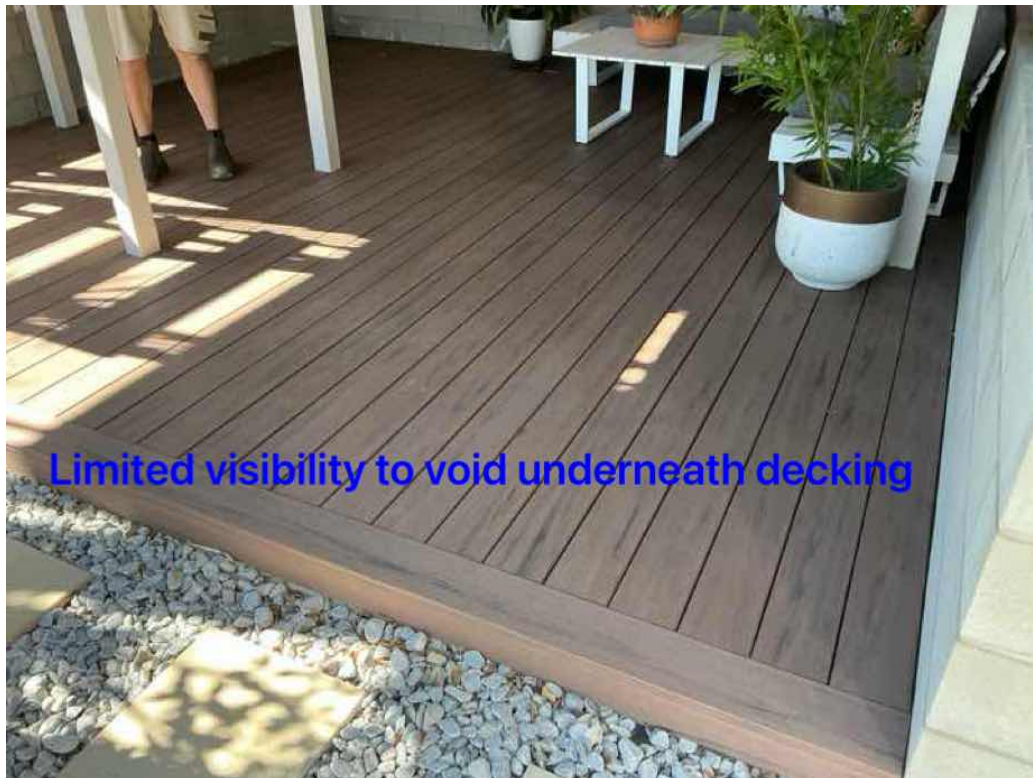
No inspection of zero boundary area was possible.

Unable to access void underneath decking.

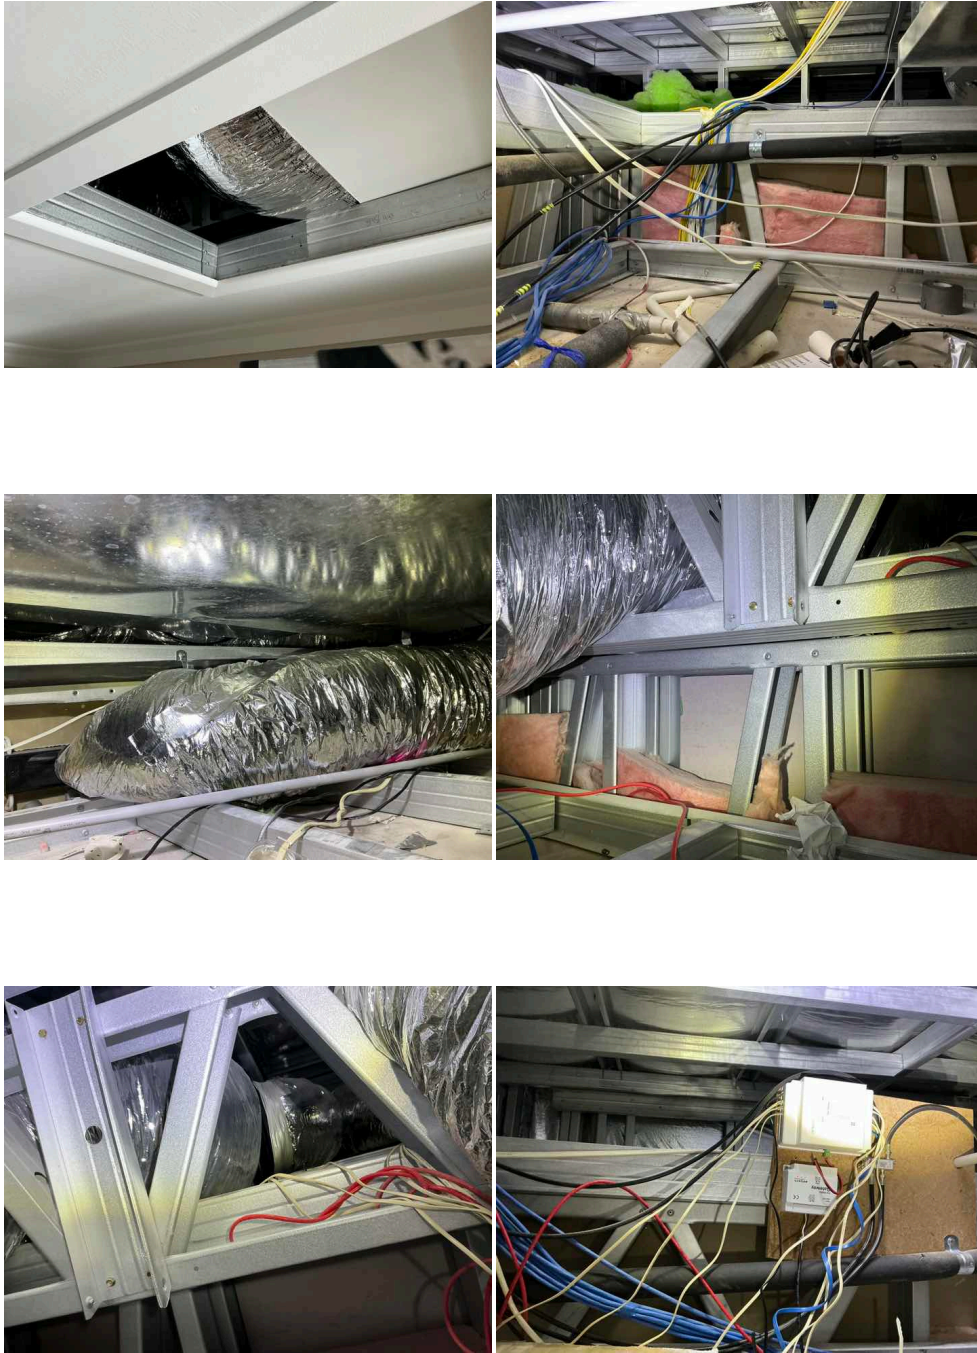
### **Roof Void Because**

No inspection of low inaccessible area of roof was possible. Receding trusses makes access difficult or impossible.

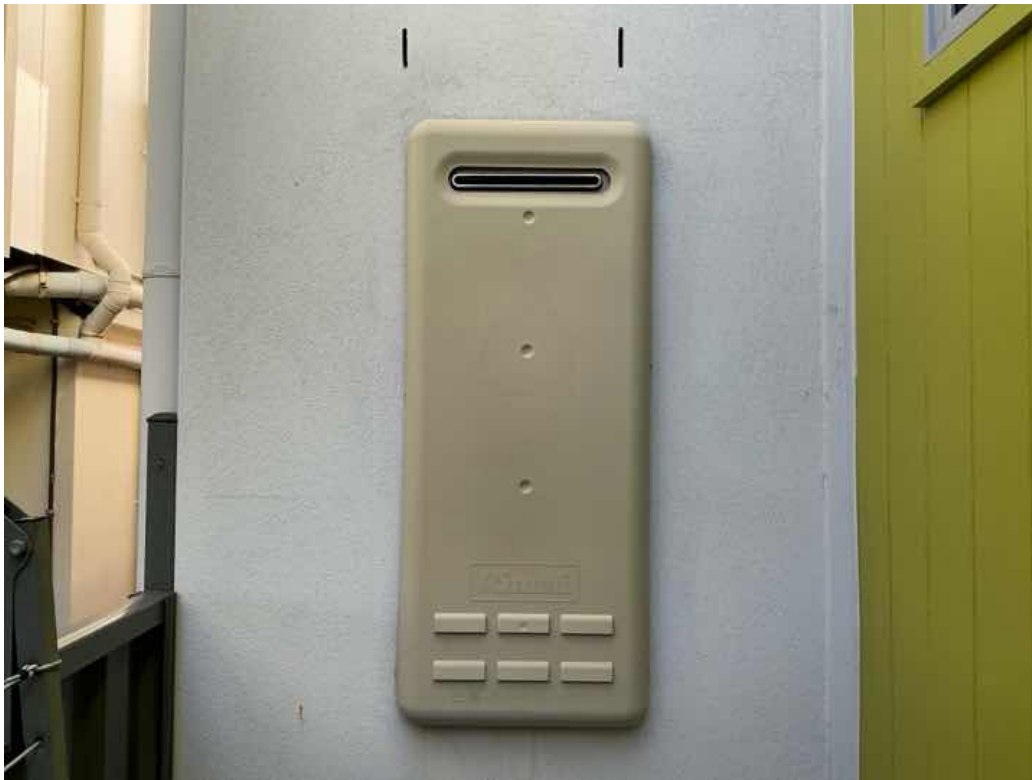
#### **Was the Overflow Sufficiently Drained?**

Not applicable to this type of hot water system.

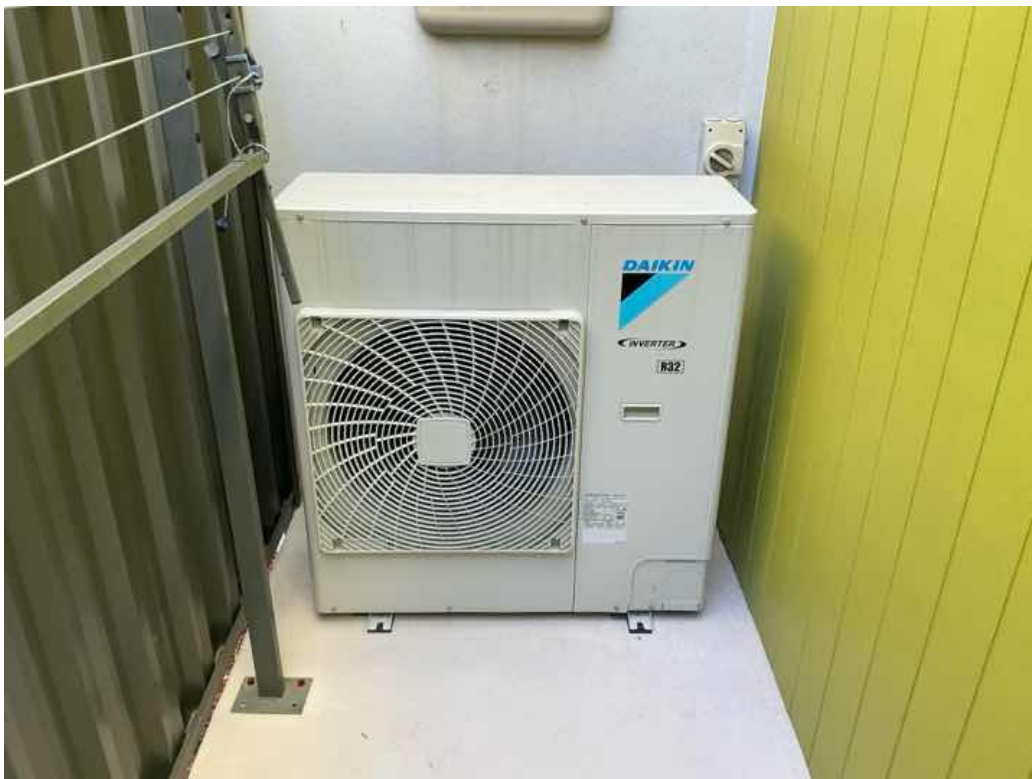
**Was the Air Conditioner Sufficiently Drained?**

Not Applicable to this unit.

The system in place is a ducted sytem, with drainage plumbed in.

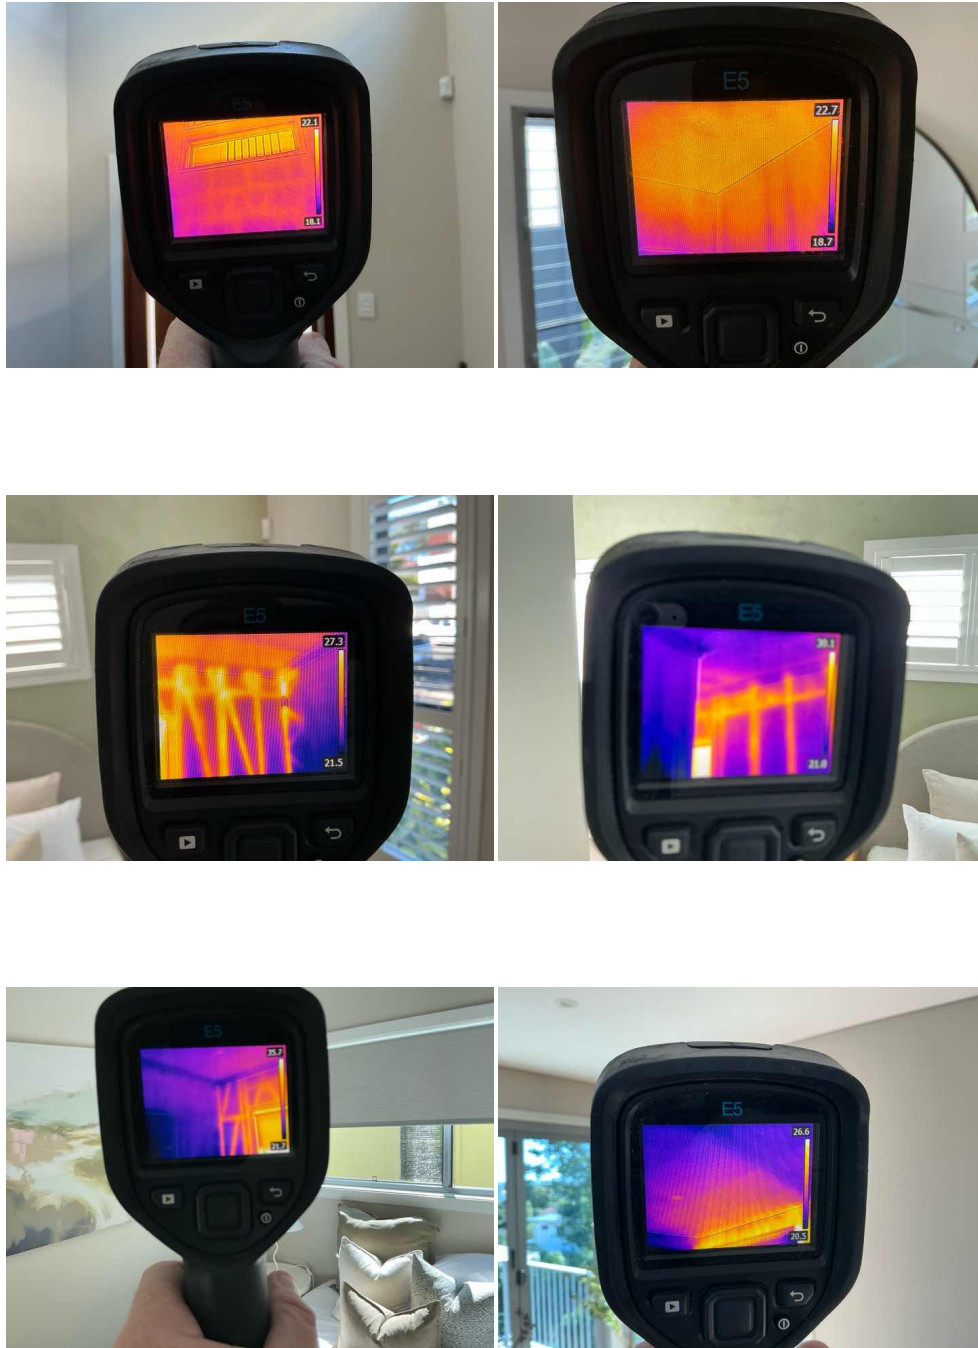
### Observation

No thermal anomalies were detected.

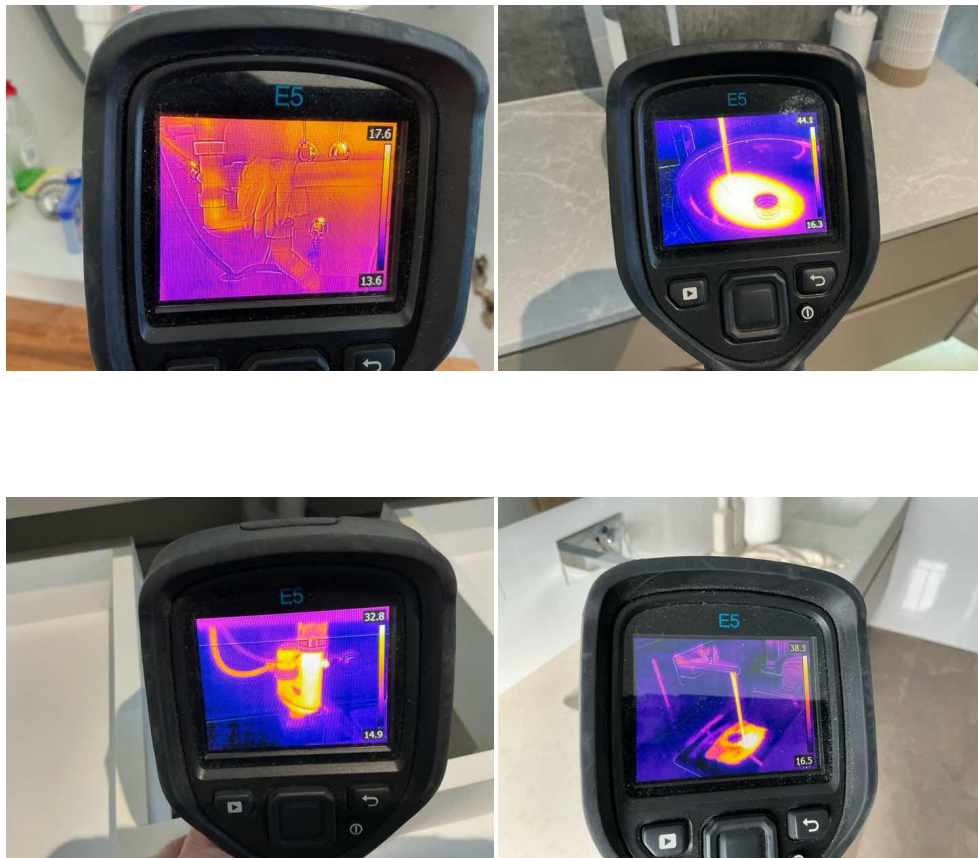
### Observation(1)

No thermal anomalies were detected.

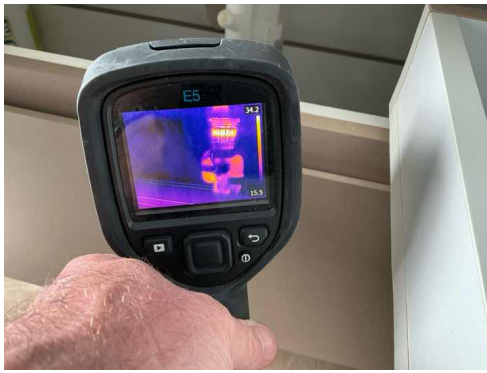
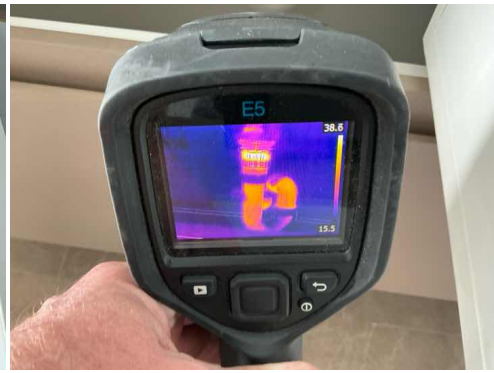
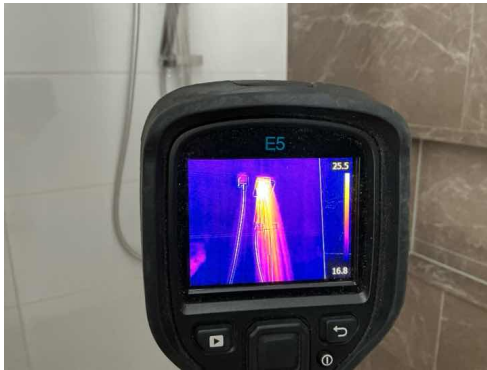
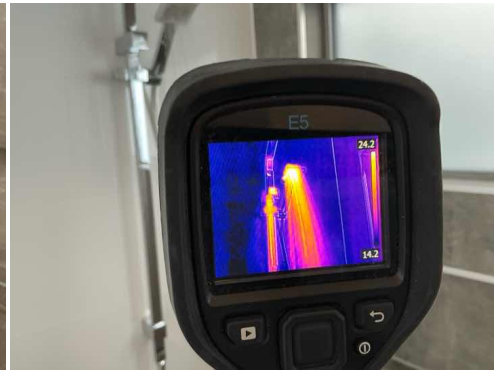
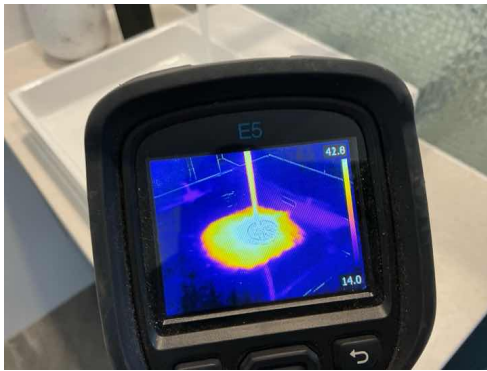
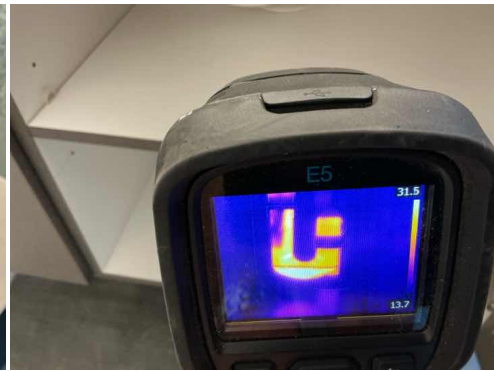
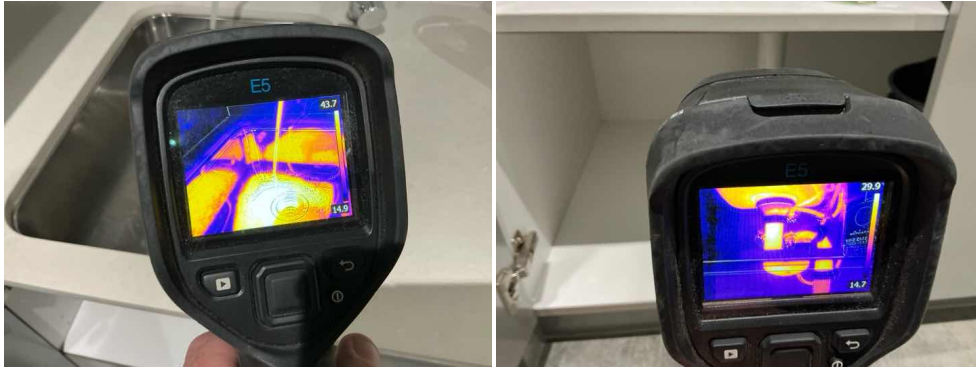
An infrared thermal imager was used as part of this inspection. The effectiveness of thermal imaging may be limited by factors such as visual obstructions, ambient temperature, wall construction, surface material, and insulation. Where surfaces are obstructed or otherwise inaccessible, accurate thermal readings cannot be obtained and are excluded from the scope of this inspection. Any observations made are based solely on conditions visible at the time of inspection and do not guarantee the absence of issues in areas that could not be assessed.

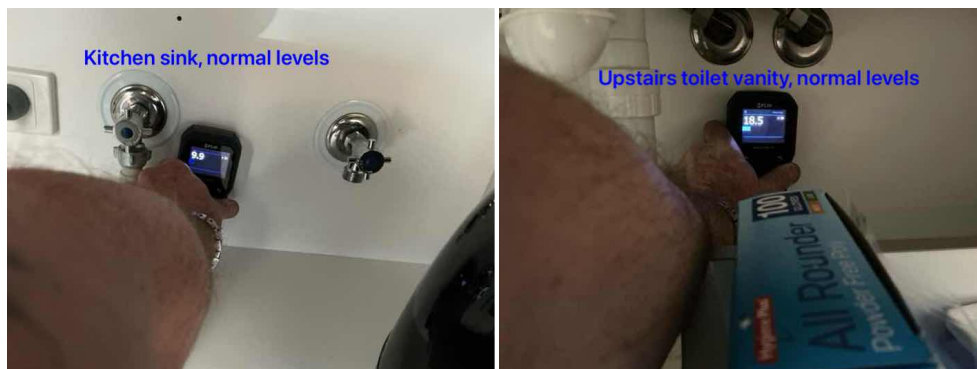
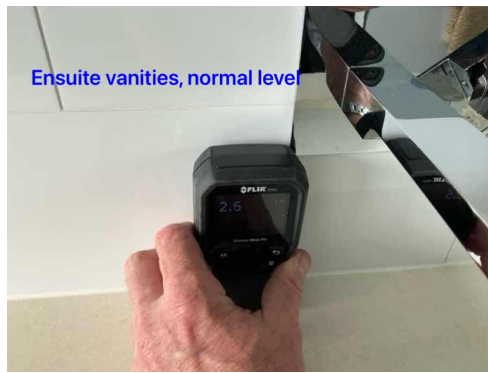
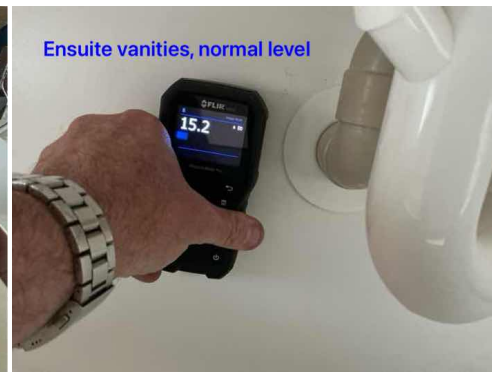
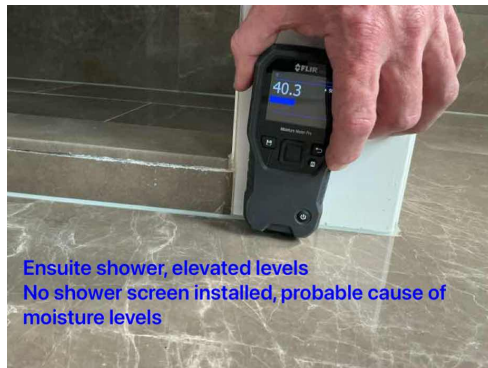
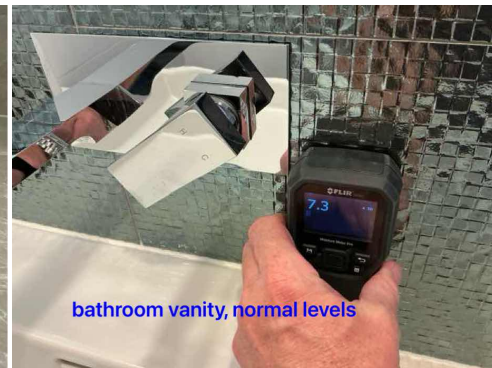
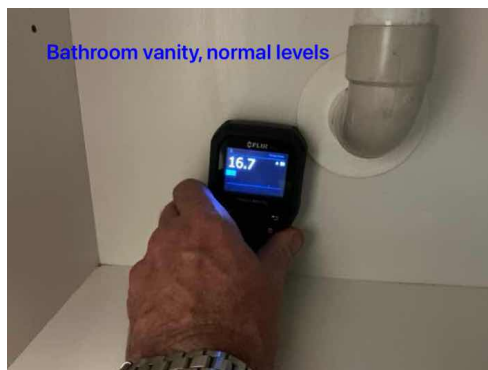
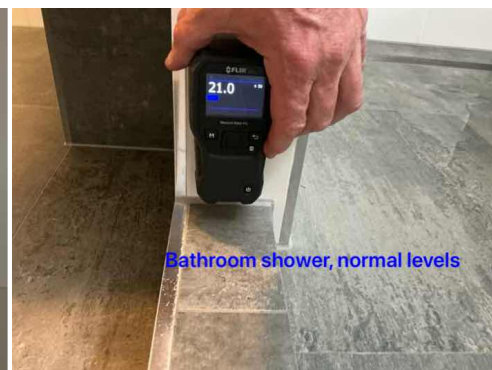
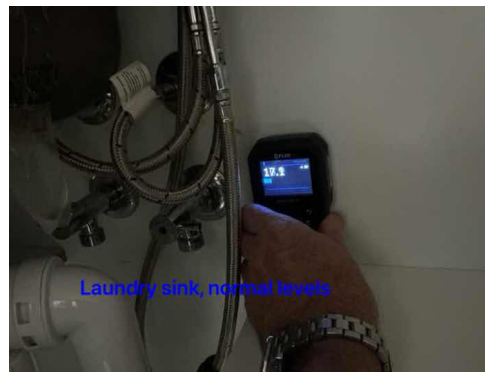
At the time of inspection, moisture levels were elevated but still in the normal range.

**Please note:** elevated or high moisture levels can still be evident even after rectification works have been carried out.

\*bathrooms in particular can take several weeks/months to completely dry out,

This is mainly due to lack of ventilation and high humidity levels associated with a bathroom.
